THE RIVER BEND NATURE CENTER  
AT  
THE HISTORIC CAMP GYPSY

SILOAM SPRINGS, ARKANSAS

**Site Design**

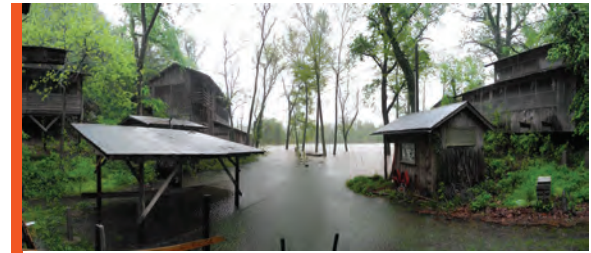
**2011**  
A five-hundred year flood event ravaged the Gypsy Camp. Flood waters inundated many of the camp structures. The interiors of several buildings have significant water damage.

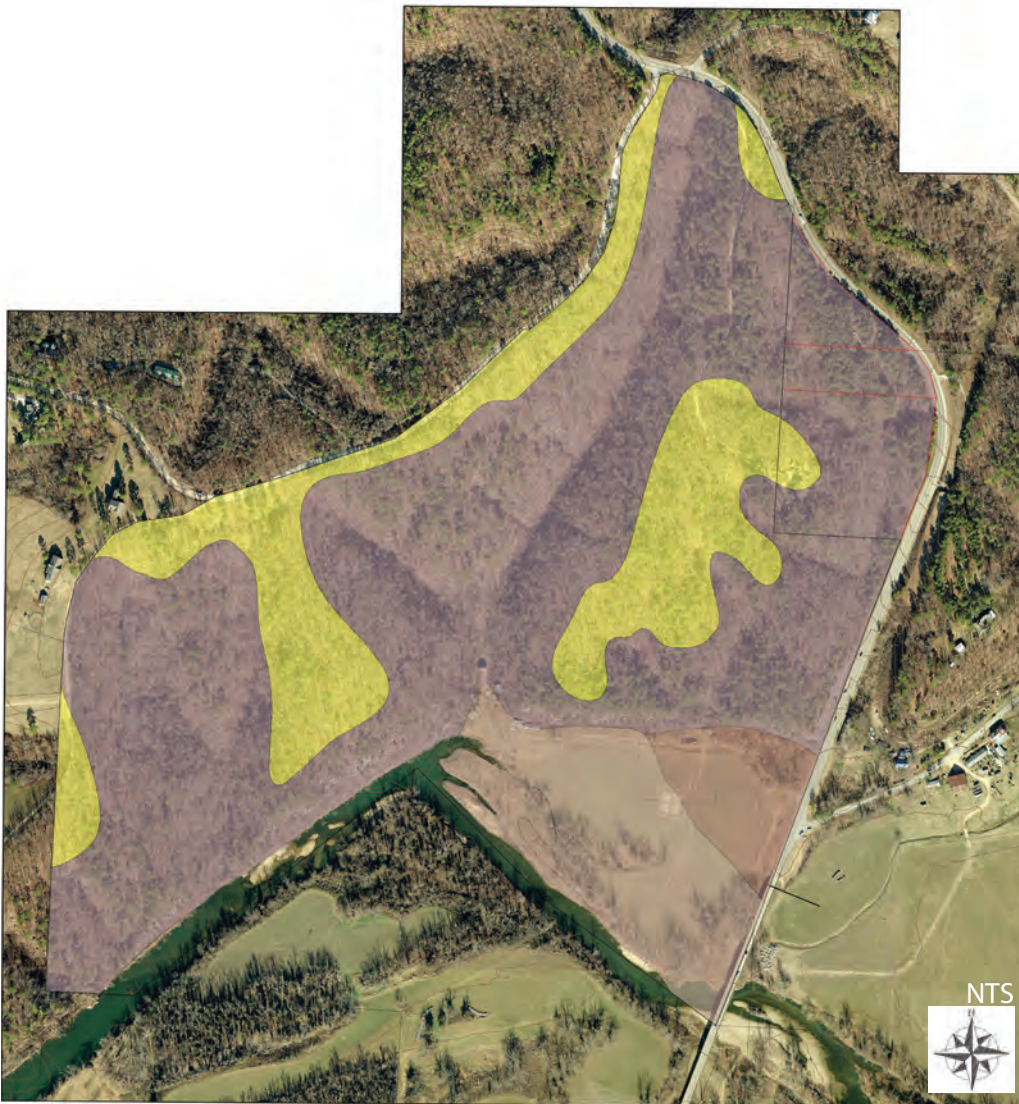
**Inventory:** The Geology of the Gypsy Camp consists of sedimentary stone. The site has many karst topographic features composed of highly weathered limestone and shale. All geologic formations on the site have been formed and shaped by water over many millennia.

**Analysis:** Areas in the NfD category are the most buildable due to low slope. Areas in the CvF category are moderately buildable due to steep slopes. Construction in these areas would be the most costly on the site. Areas in the He and Hf categories would be unbuildable as a result of their location in the floodplain.

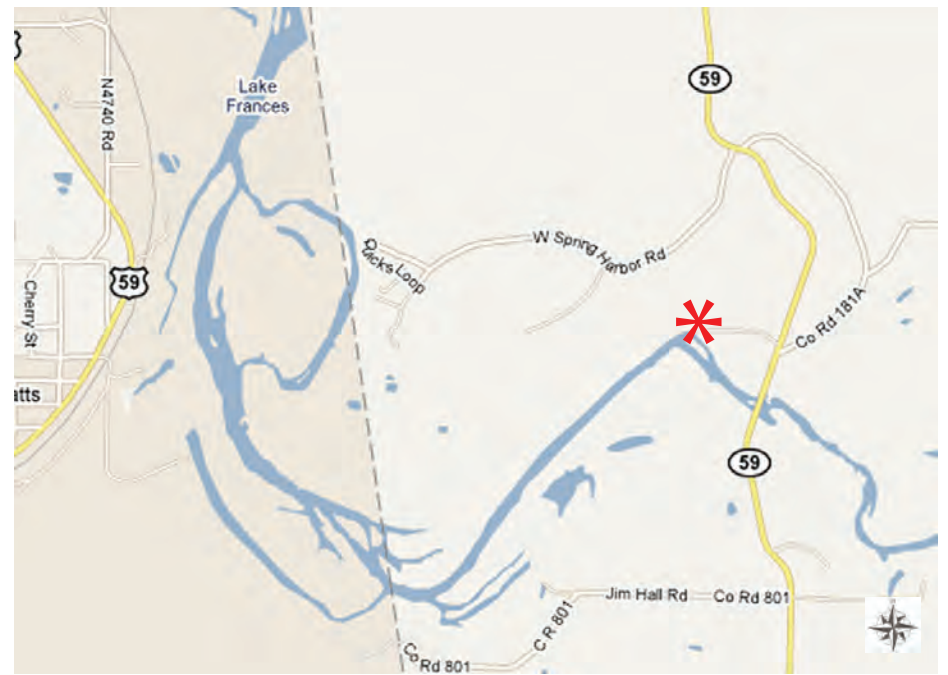
Lake Frances after 1992 Google Maps

**Inventory:** The Gypsy Camp was located on the upper end of Lake Frances. Lake Frances was constructed in the early 1900's as part of a resort community by the same name. The resort community was approximately a mile north of the Gypsy Camp. The Hotel was torn down in the mid to late 1960's. In February of 1992 a large portion of the dam washed out as a result of a large storm and many years of neglect. The lake level dropped approximately five feet at the Gypsy Camp.

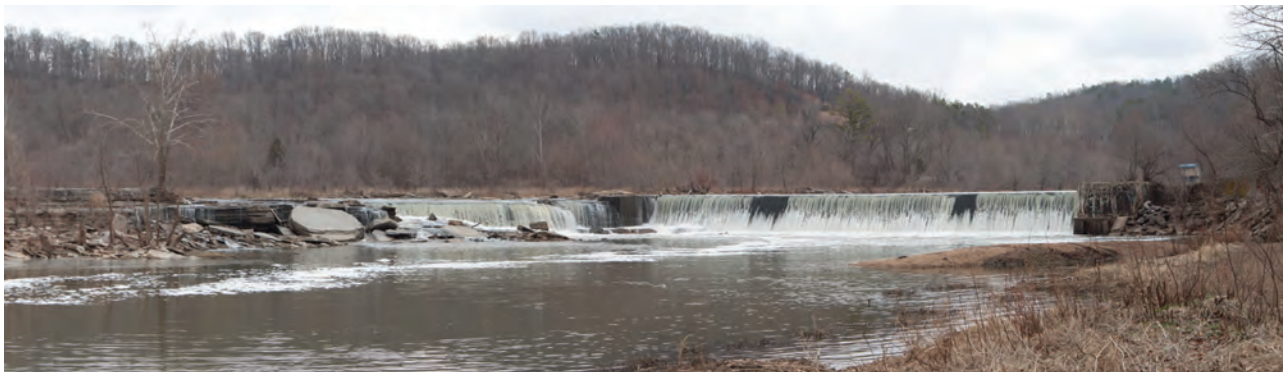
Remains of the historic Lake Frances Dam in 2011

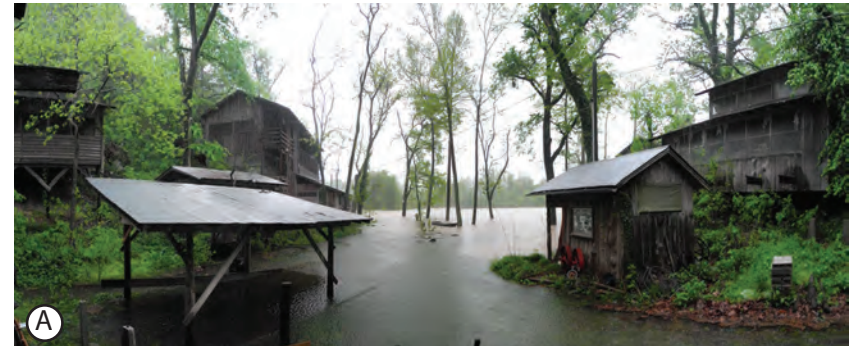
The Illinois River rose another six feet after photograph was taken

**Analysis:** Seasonal flooding in the Illinois River Valley results in the Gypsy Camp being inaccessible for short periods of time during the spring. This is a direct result of its location in the flood plain. Any new buildings will need to be built above the flood plain in order to have year round use.

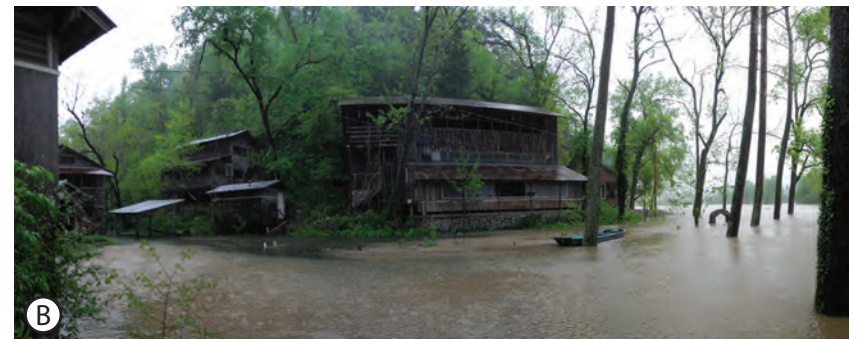
Rising Floodwater with "Tree Top" in the background.

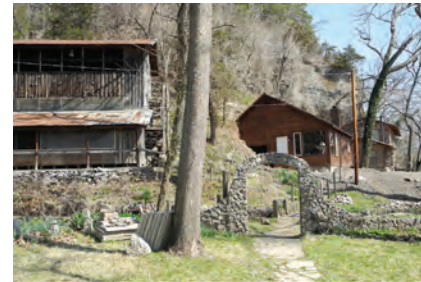
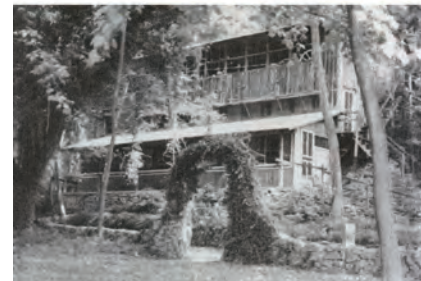
**A) Rock Wall**  
**Date of Construction:** 1921  
**Materials:** Limestone  
**Condition:** Good

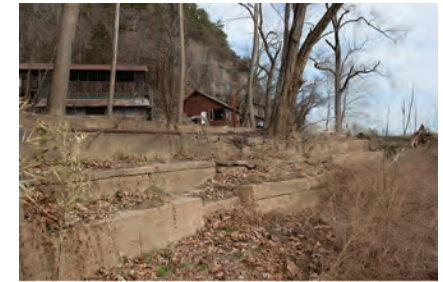
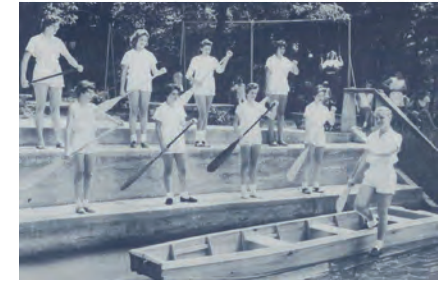
**B) Boat Dock**  
**Date of Construction:** 1923  
**Materials:** Concrete  
**Condition:** Fair

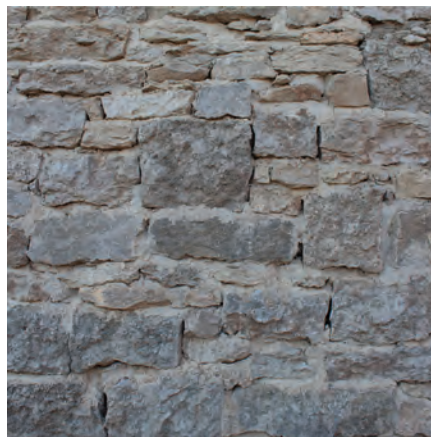
Native Limestone

**Inventory:** The buildings at the Gypsy Camp were built in the rustic style. They were constructed from many of the same vernacular materials that the earliest settlers used when moving into the Ozark Region. All of the buildings dating from the 1920's were built from lumber that was harvested and milled on site. Later additions and remodels used milled lumber that was purchased locally. The resulting style was an eclectic mix of vernacular materials that give the Gypsy Camp the architectural character that is seen today.

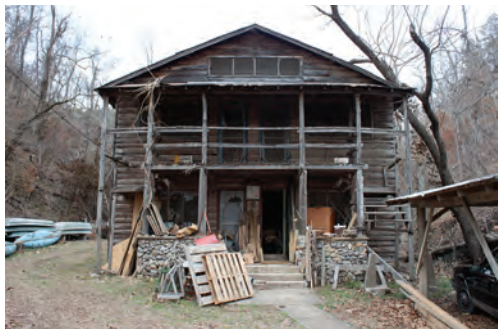
### A) "Queen's Tavern"

**Date of Construction:** 1925

**Architecture:** Rustic wood framed structure on limestone foundation.

**Condition:** Good, Access to upper level is limited due to the deterioration of stairs.

**Original Use:** Dining & Recreation Hall

**Current Use:** Owner's Wood Shop, Storage

The core of the Gypsy Camp has remained largely intact with only a few minor changes in the past twenty-five years. The Queen's Tavern as seen in the image above has lost both stair cases on its front, and has damage from the 2011 flood.

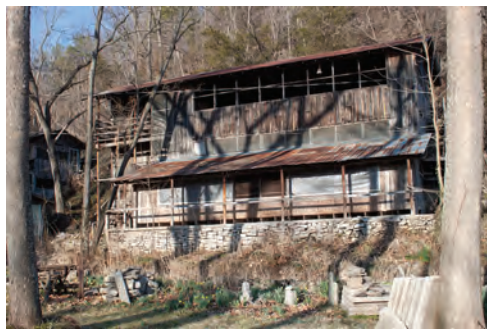
### B) Tree Top Inn, Devil's Den, Angel's Alley

**Date of Construction:** 1921

**Architecture:** Rustic wood framed structure on limestone foundation

**Condition:** Good, Access is limited due to the deterioration of stairs.

**Original Use:** Dining, Sleeping Quarters, and Recreational Hall until Queen's Tavern was constructed. After 1925 structure housed Arts and Crafts, Sleeping Quarters, and a Nurse's Station

**Current Use:** Vacant/ Storage

Treetop Lodge has lost its exterior staircase. The upper floors of the structure are still accessible by way of an interior staircase. The lower level of the structure had some damage during the 2011 flood.

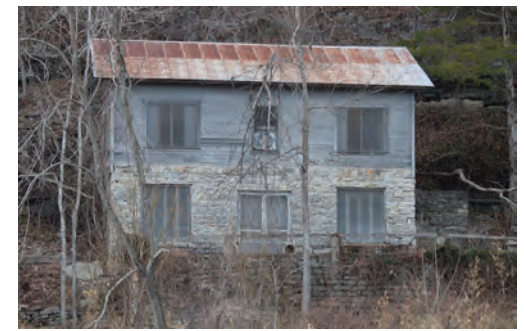
### C) Coe House

**Date of Construction:** 1921, Rebuilt 1928

**Architecture:** Original log structure was destroyed by a fire. Existing structure is two stories. Ground floor is constructed of limestone and the second floor is framed with wood. Structure is built on a limestone foundation.

**Condition:** Good

**Original Use:** Residence

**Current Use:** Vacant/ Storage

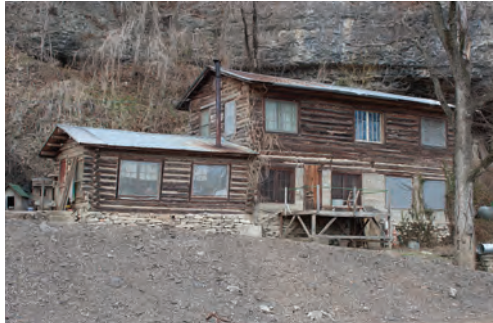
### G) McAllister - Coe House "Royal Hut"

**Date of Construction:** 1923

**Architecture:** Log and multi-story rustic wood framed structure on limestone foundation.

**Condition:** Fair

**Original Use:** Residence (1923-2011)

**Current Use:** Vacant/ Storage

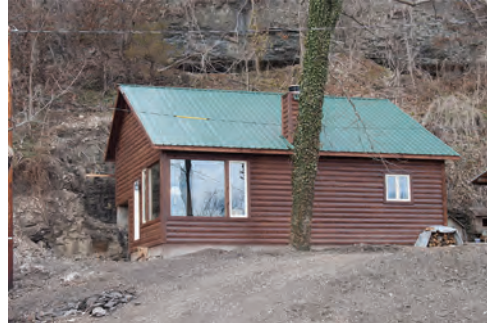
### H) River View Cabin

**Date of Construction:** 2011

**Architecture:** Contemporary wood framed structure with stained pine veneer on concrete slab foundation.

**Condition:** New

**Original Use:** Residence

**Current Use:** Same

The construction of the River View Cabin in 2011 on the edge of the camp's central core has changed the character of the camp.

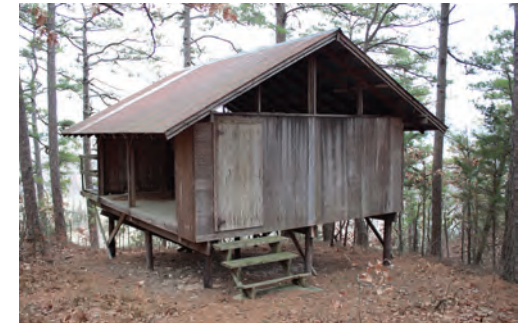
### I) Sleep-Out Cabin "Wildflower"

**Date of Construction:** c. 1965

**Architecture:** Rustic framed structure on post foundation.

**Condition:** Good

**Original Use:** "Sleep-Out Cabin" a once-a-week getaway for the girls

**Current Use:** Vacant

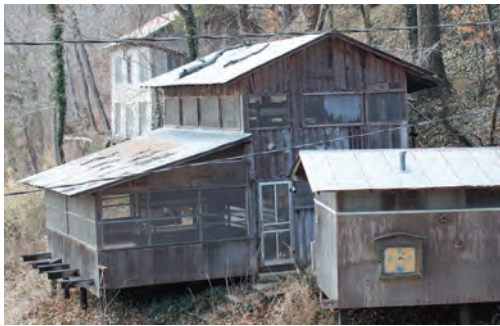
**D) Romany Inn (Top) & Vagabond Villa (Bottom)**

**Date of Construction:** 1928

**Architecture:** Rustic board and batten wood framed structure on post foundation.

**Condition:** Good, Access is limited due to the deterioration of stairs.

**Original Use:** Cabin for older aged girls.

**Current Use:** Vacant/ Storage

Romany Inn is structurally sound. The staircase and railings leading into the structure are unstable. The lower level of the cabin had some damage in the 2011 flood.

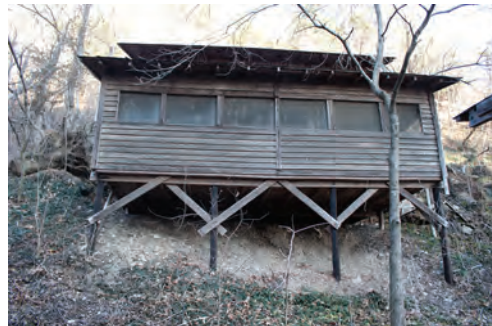
**E) Upper and Lower Rover's Rest**

**Date of Construction:** 1928

**Architecture:** Rustic board and batten wood framed structure on post foundation.

**Condition:** Good, Access is limited due to the deterioration of stairs.

**Original Use:** Cabin for younger girls.

**Current Use:** Vacant/ Storage

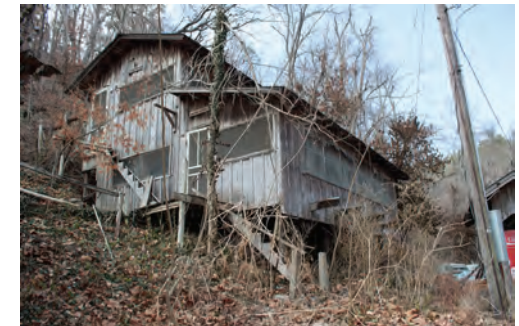
**F) Upper & Lower Gypsy Cabins**

**Date of Construction:** 1928

**Architecture:** Rustic wood framed structure situated on post foundation.

**Condition:** Good, Access is limited due to the deterioration of stairs.

**Original Use:** Cabin for middle aged girls.

**Current Use:** Vacant/ Storage

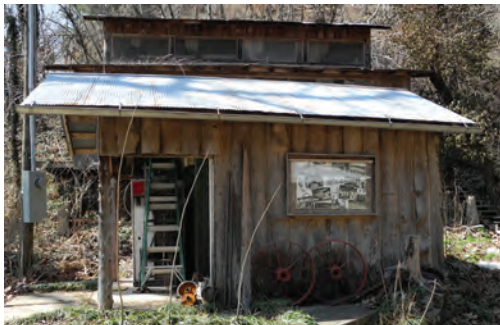
**J) Well House and Canteen**

**Date of Construction:** 1921

**Architecture:** Rustic wood framed structure on concrete foundation.

**Condition:** Good

**Original Use:** Well House/ Canteen

**Current Use:** Well House/ Storage

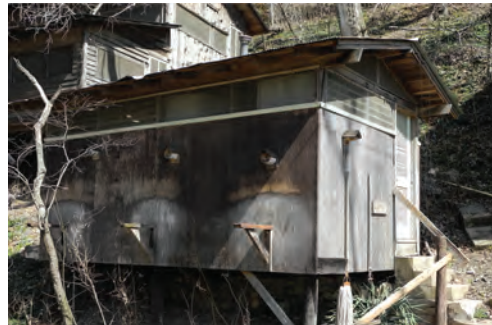
**K) Restroom and Shower Buildings**

**Date of Construction:** Two structures, c. 1960

**Architecture:** Wood framed structure on post foundation.

**Condition:** Good

**Original Use:** Restrooms and Showers

**Current Use:** Vacant

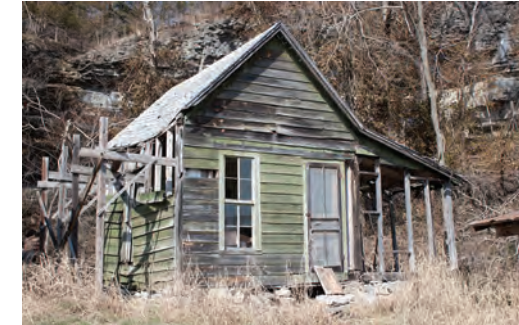
**L) The Indian House "The Gate House"**

**Date of Construction:** c. 1910

**Architecture:** Wood framed structure with stained pine siding on limestone foundation.

**Condition:** Very Poor

**Current Use:** Vacant/ Uninhabitable

The Indian House (The Gate House) has fallen into disrepair during the past two decades. The structure will likely need to be reconstructed as a result of its poor condition.

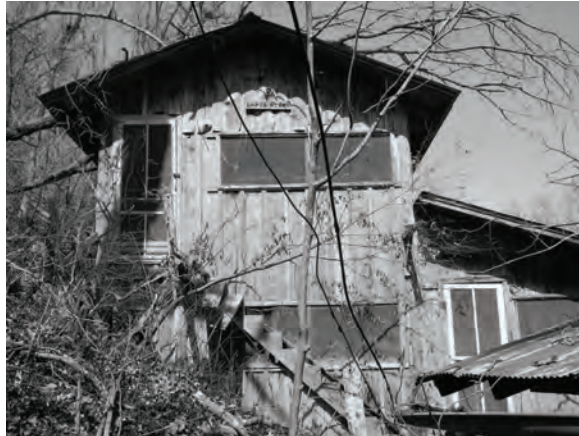
The Upper Gypsy cabin while structurally sound has become inaccessible due to the loss of the staircase leading to the second floor.

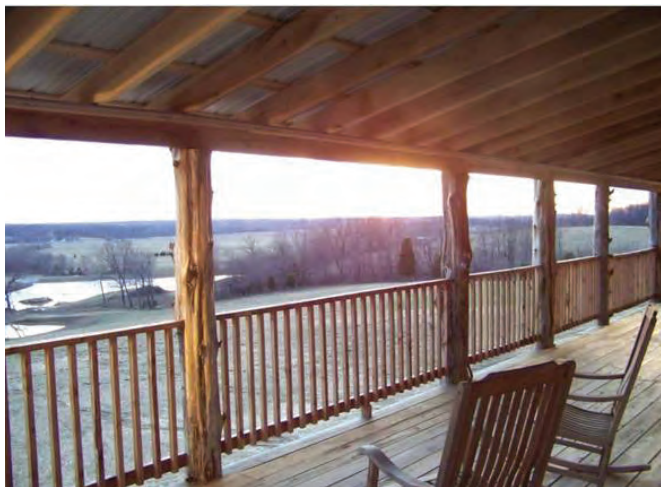
The reception hall at the River Bend Nature Center will be a rustic log structure with a large majestic wraparound porch that offers panoramic views onto the great lawn.

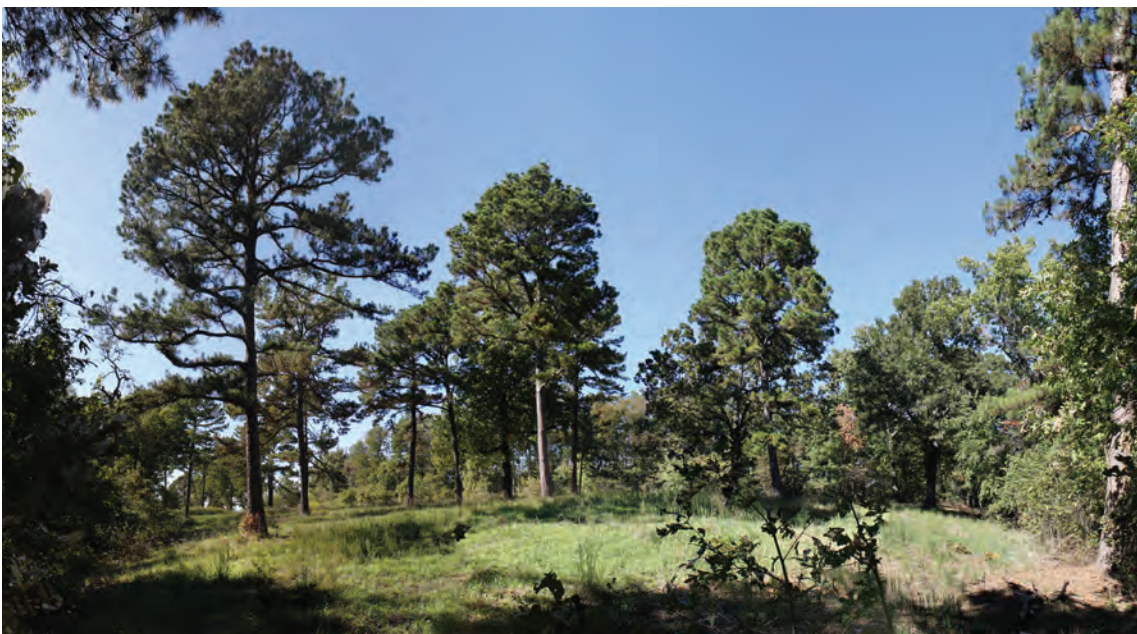
The Parking and reception hall will try to retain many of the existing Pine Trees as possible. Many more pine trees will be added to the existing in order to create a pine forest which will create a parking area that is interspersed with pine trees that coat the ground with their pine needles.

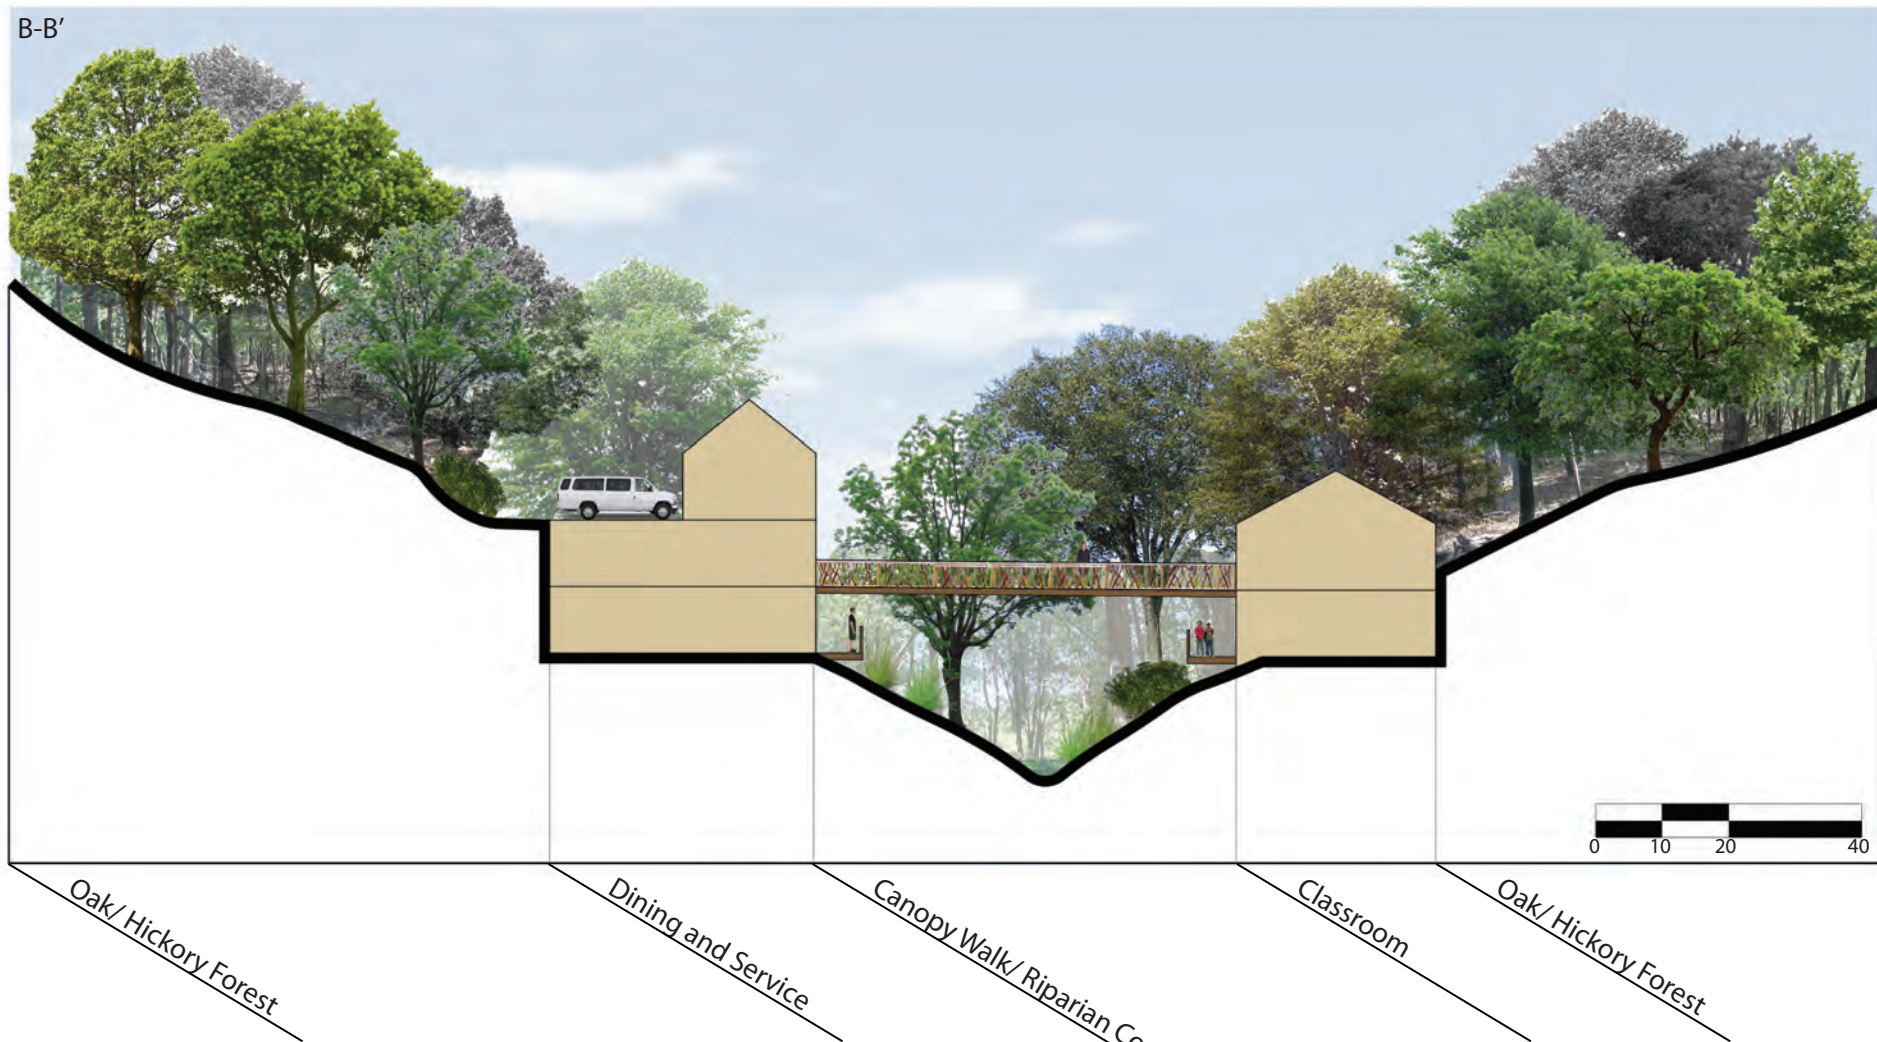
**Section B-B'** shows the canopy walk that connects the dining hall to the classroom building across the valley. Parking for service vehicles is located on the roof of the dining hall to reduce the amount of unnecessary grading. Boardwalks along the edges of the valley provide views into the riparian corridor.

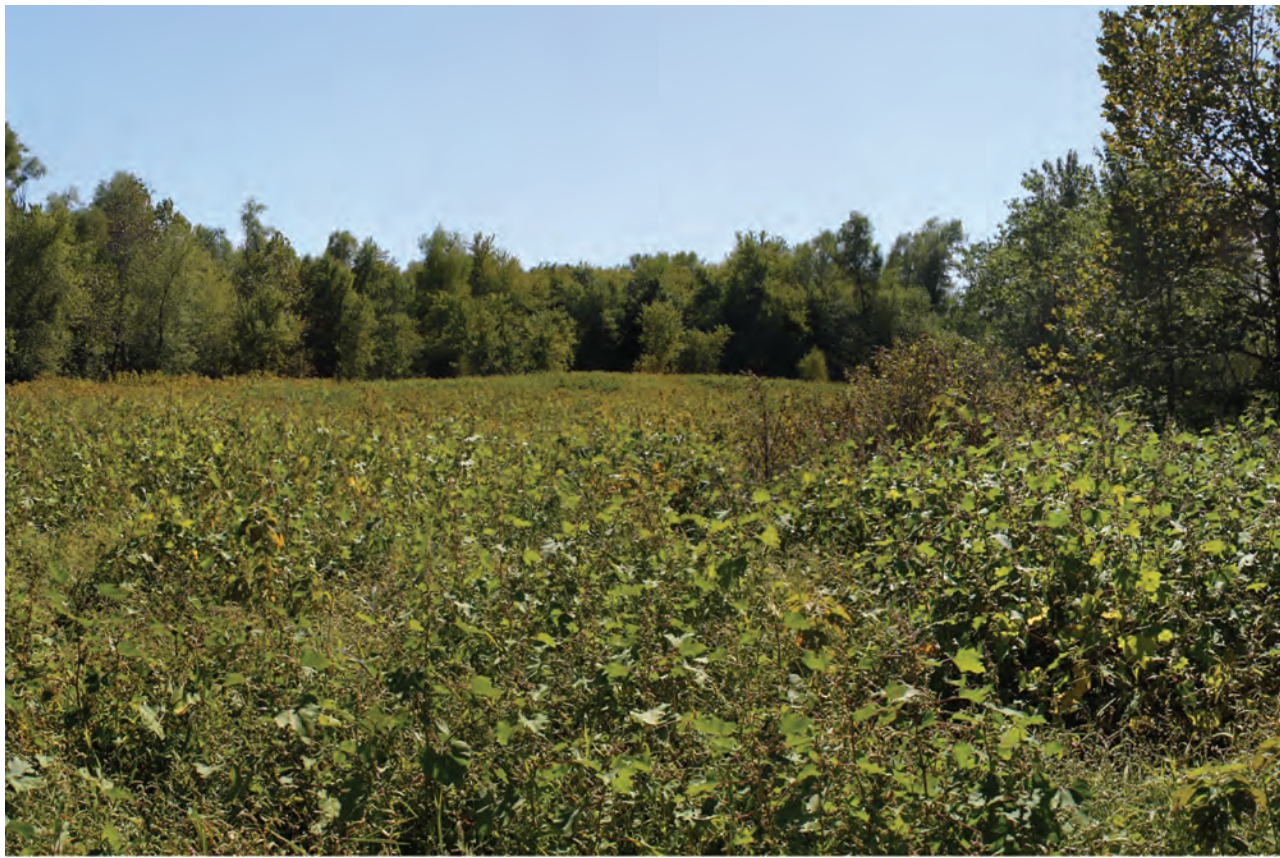
### Seasonal Wetland Prairie (9.47 Acres)

- Bladder Sedge (*Carex intumescens*)
- Canada Bluejoint (*Calamagrostis canadensis*)
- Beaked Panic Grass (*Panicum anceps*)
- Canadian Wild Rye (*Elymus canadensis glaucifolius*)
- Crimson Eyed Rosemallow (*Hibiscus moscheutos*)
- Eastern Gama Grass (*Tripsacum dactyloides*)
- Fowl Bluegrass (*Poa palustris*)
- Grassleaved Goldenrod (*Euthamia graminifolia*)
- Indian Grass (*Sorghastrum nutans*)
- Joe Pye Weed (*Eupatorium purpureum*)
- Little Bluestem (*Schizachyrium scoparium*)
- Pennsylvania Smartweed (*Persicaria pensylvanica laevigata*)
- Purple Top (*Tridens flavus*)
- Redtop Panicgrass (*Panicum rigidulum*)
- Smooth Panicgrass (*Panicum dichotomiflorum*)
- Tall Coreopsis (*Coreopsis tripteris*)
- Turks' Cap Lily (*Lilium superbum*)
- Woolgrass (*Scirpus cyperinus*)

The ecological images show areas along the Illinois River that represent the proposed ecosystems after a successful restoration. These areas are located in what was once part of the Lake Frances lake bed. These areas have returned to their native state through natural re-vegetation that has taken place during the past twenty years. The goal of the ecological restoration at the Gypsy Camp is to speed up the natural process seen in the images through the reintroduction of healthy native plants that would have once thrived along the Illinois River.

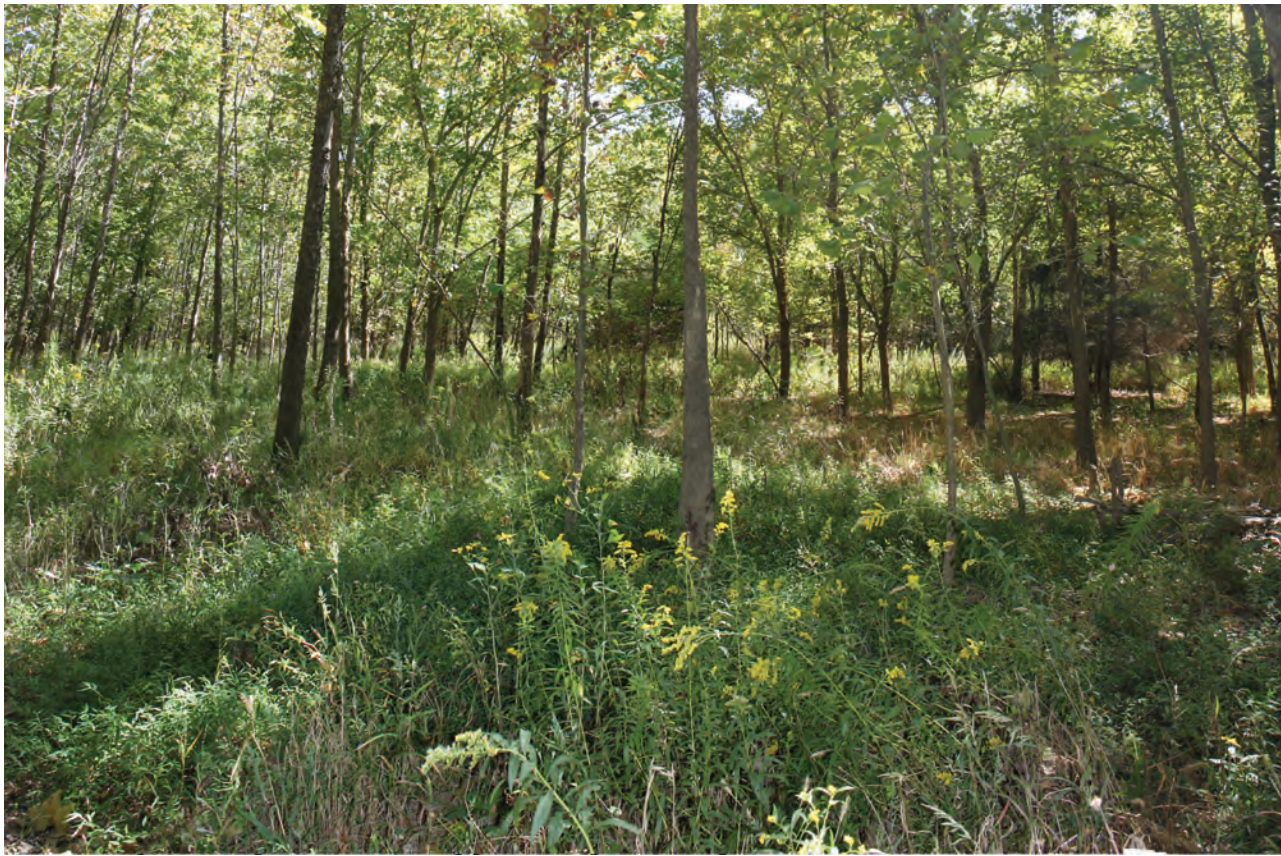
**Wetland Woodland (8.19 Acres)**

- Arrowwood *Viburnum dentatum*
- Black Chokeberry (*Aronia melanocarpa*)
- Bottlebrush Grass (*Elymus hystrix*)
- Eastern Gamagrass (*Tripsacum dactyloides*)
- Green Ash (*Fraxinus pennsylvanica*)
- Hercules' Club (*Aralia spinosa*)
- Inland Sea Oats (*Chasmanthium latifolium*)
- Native Pecan (*Carya illinoensis*)
- Ninebark (*Physocarpus opulifolius*)
- Nodding Bur Marigold (*Bidens cernua*)
- Osage Orange (*Maclura pomifera*)
- Pinebarren Goldenrod (*Solidago fistulosa*)
- Rice Cutgrass (*Leersia oryzoides*)
- River Locust (*Amorpha fruticosa*)
- Sandbar Willow (*Salix exigua ssp. interior*)
- Shining Aster (*Aster firmus*)
- Virginia Wild Rye (*Elymus virginicus*)
- Winterberry (*Ilex verticillata*)

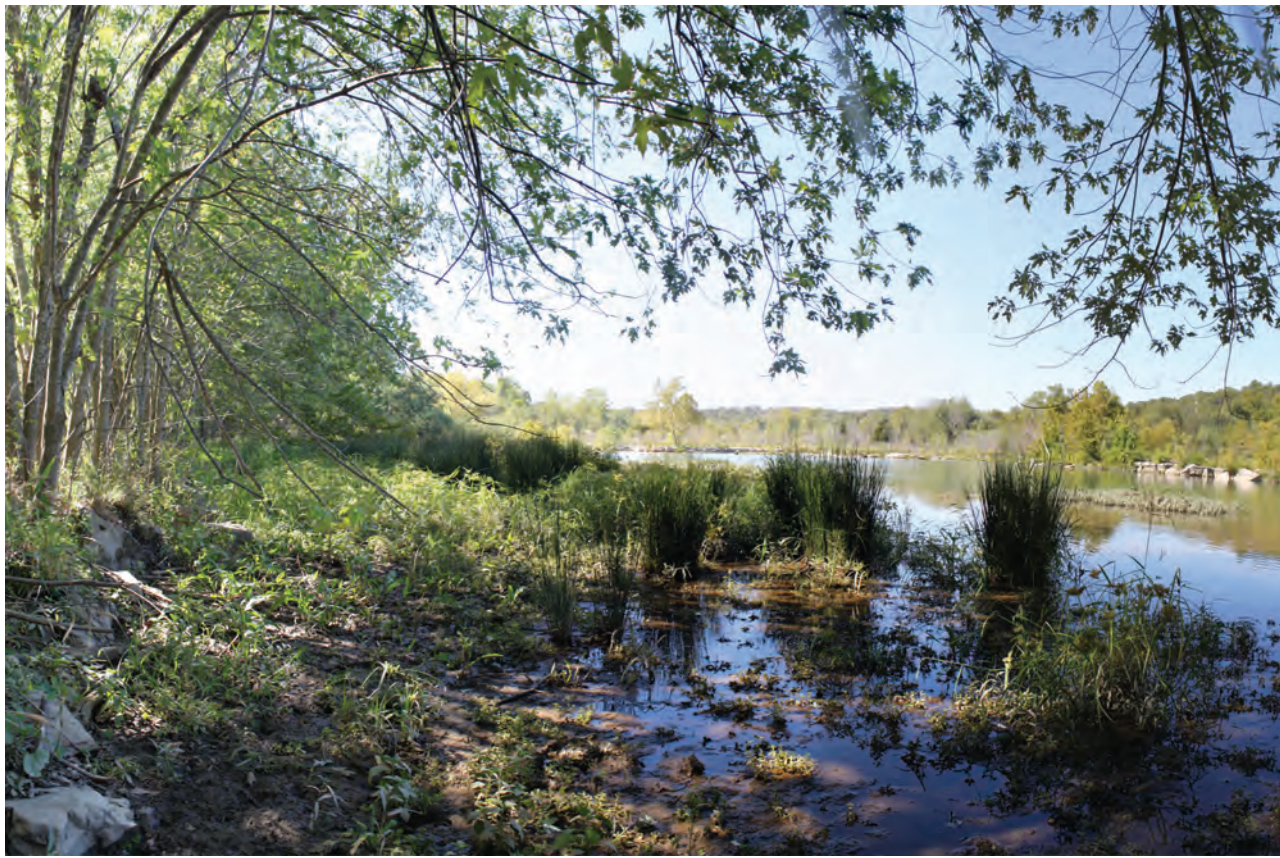
### Riparian Wetland (1.05 Acres)

Canadian Rush (*Juncus canadensis*)  
 Eastern Gama Grass (*Tripsacum dactyloides*)  
 Floating Managrass (*Glyceria borealis*)  
 Green Bulrush (*Scirpus atrovirens*)  
 Leathery Rush (*Juncus coriaceus*)  
 Soft Stem Bulrush (*Scirpus validus*)  
 Many leaved bulrush (*Scirpus polyphyllus*)  
 Pennsylvania Smartweed (*Persicaria pennsylvanica laevigata*)  
 Smooth Panic Grass (*Panicum dichotomiflorum*)  
 Reed Canarygrass (*Phalaris arundinacea*)  
 Rice Cutgrass (*Leersia oryzoides*)  
 Arrow Arum (*Peltandra virginica*)  
 Riddell's Goldenrod (*Solidago riddellii*)  
 Roughleaf Goldenrod (*Solidago patula*)  
 Swamp Milkweed (*Asclepias incarnata*)  
 Turtlehead (*Chelone glabra*)
